RAILWAY INVESTIGATION REPORT

R02C0050

DERAILMENT

**CANADIAN NATIONAL
TRAIN NUMBER A-442-51-08
MILE 52.1, CAMROSE SUBDIVISION
NEAR CAMROSE, ALBERTA
08 JULY 2002**

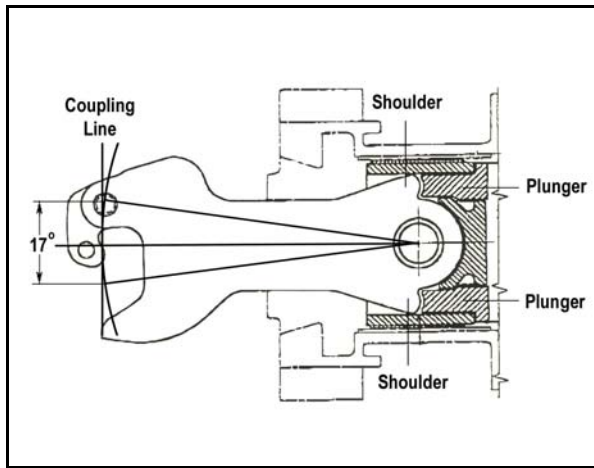
Figure 2. Coupler with alignment gear (plunger)

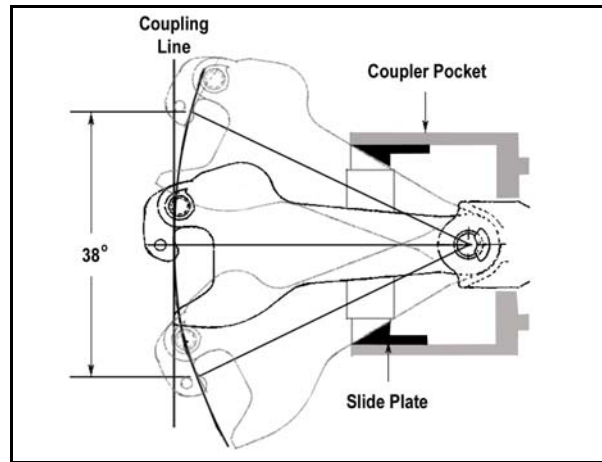
Figure 3. Coupler without alignment gear

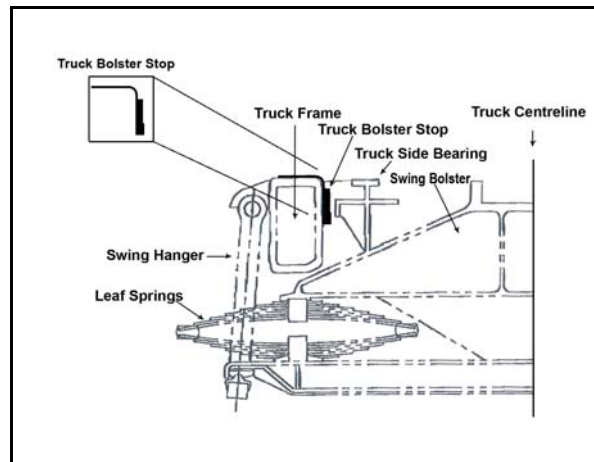
Figure 4. Truck with bolster stop

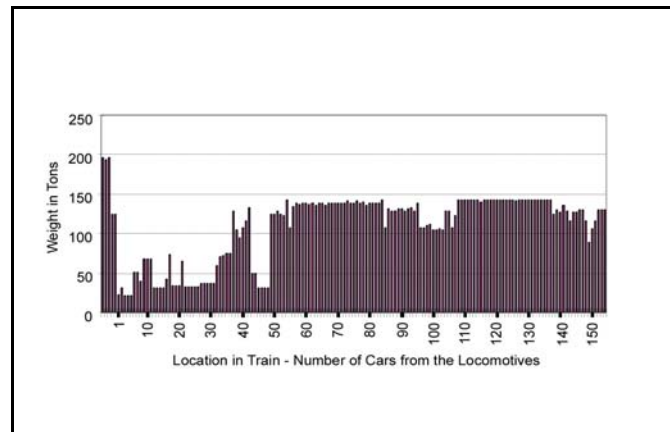
On 08 July 2003, train 442 had empty and lightly loaded cars totalling 2480 tons immediately behind the locomotive consist and ahead of loaded cars totalling 13 885 tons (see Figure 5).

Figure 5. Tonnage profile for train 442

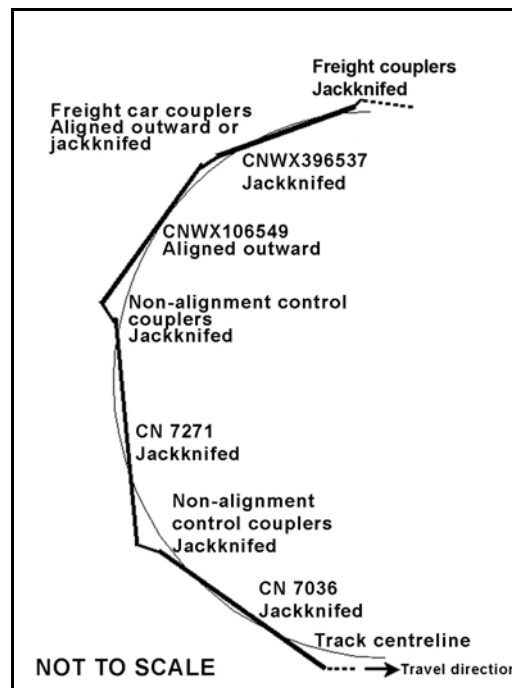
When a train is in buff on curved track, the car bodies and couplers are either aligned to one side or jackknifed⁷ (see Figure 6). Aligned to one side of a car body means that the two trucks of the car are against the same rail, either high or low rail, while jackknifing of a car body means that the two trucks of the car are against opposite rails. Aligned to one side of two couplers occurs between the trailing truck of one car and the leading truck of the adjacent car; the two trucks are against the same rail, either high or low rail. Jackknifing of two couplers occurs when the two trucks are against opposite rails. In both jackknifing cases, the centreline of the car body takes an angle against the centreline of the track.

- The derailment resulted from a combination of large draw bar angles due to the non-alignment control coupler of the trailing locomotive, significantly high buff forces produced by high DB application, and the extremely light tare weight of the aluminum hopper car.
- The first car behind the locomotives derailed when it was rolled aside by the lateral force transformed from the buff forces produced by DB.
- The light tare weight (vertical) of the aluminum hopper car could not balance the transformed lateral force and the lateral/vertical (L/V) ratio reached the rollover criterion.
- The couplers between the trailing locomotive, CN 7271, and the first covered hopper car, CNWX 106549, were in a jackknifing position, which increased the transformed lateral force (see Figure 6).

Figure 6. Theoretical position of cars and locomotives without alignment control gear
